# SUMMARY REPORT Historic Structures Reports and Building Preservation Plans St. Elizabeths West Campus

Washington, D.C.

**Final Report**April 12, 2010
WJE No. 2008.4286

**U.S. General Services Administration** Washington, D.C.

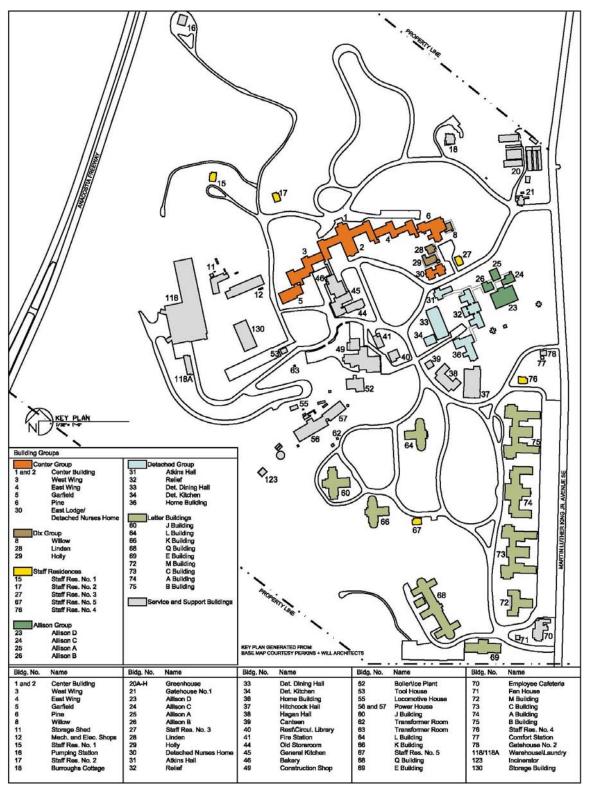
Figure 1. Site plan, 2009, showing buildings included in the Historic Structure Report and Building Preservation Plan study. Color coding indicates indicate building groups created as part of the evolution of the west campus.
